EVALUATION OF THE

750,000 Gallon Steel Elevated Water Tank

Brazil, Indiana

March 22, 2004

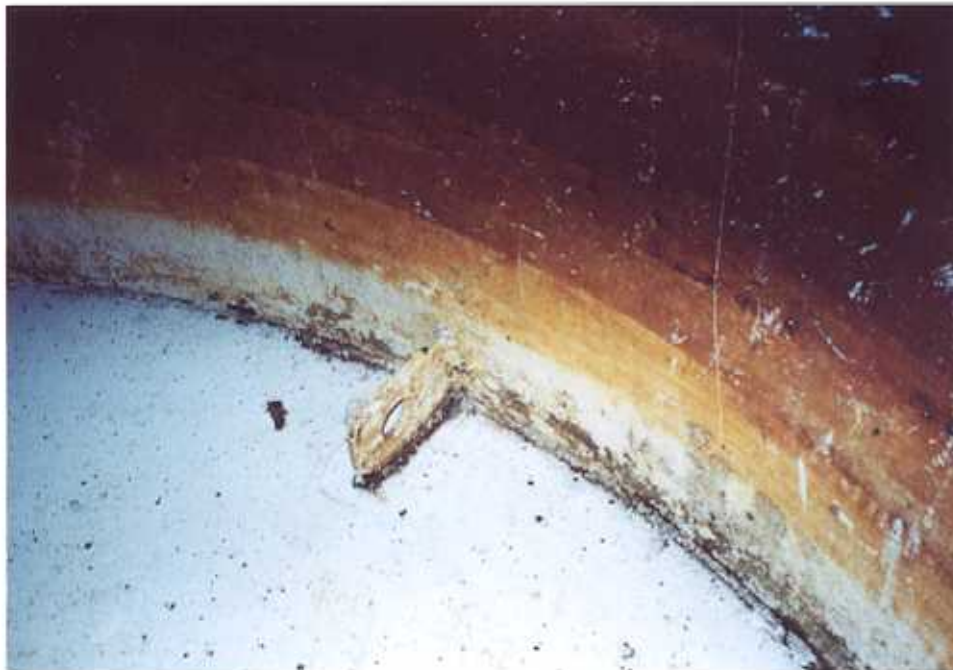
87. Bracket at riser floor.

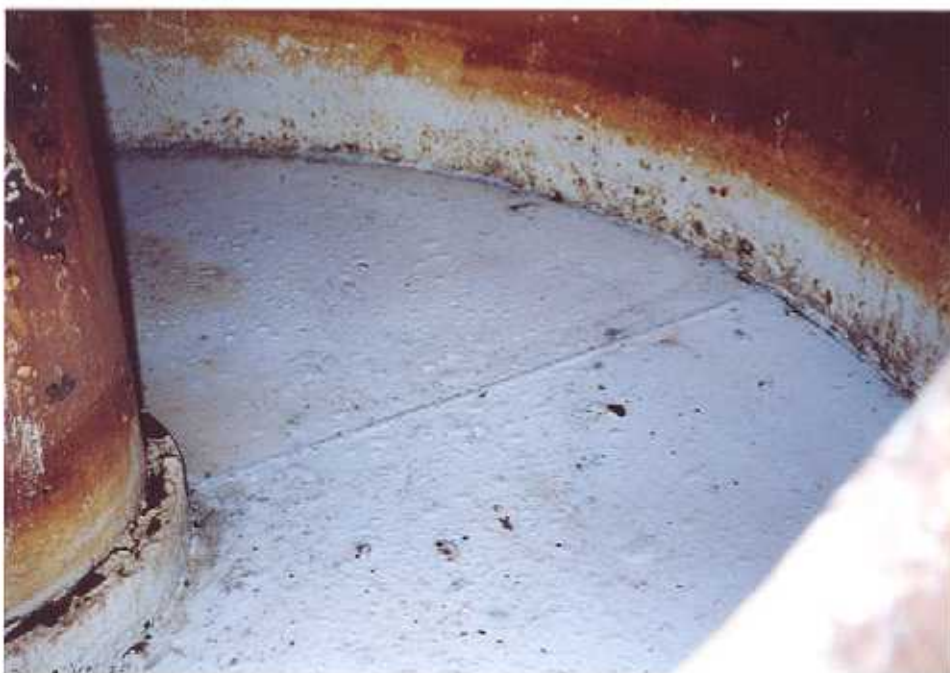
88. Blisters in coating on riser floor.

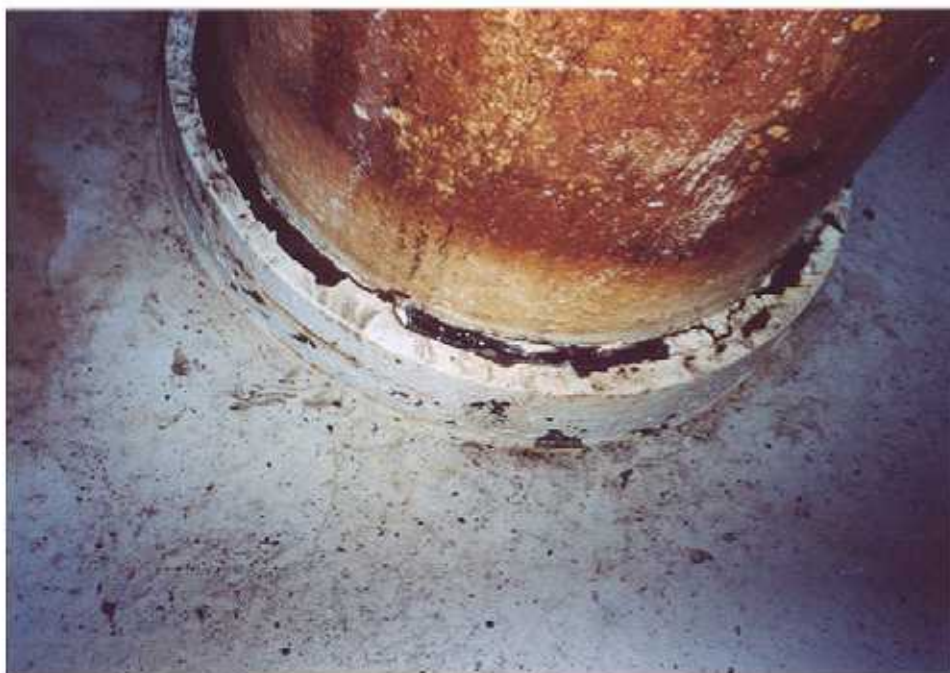
90. Inlet/outlet pipe at bottom of riser.
